ELECTRICAL SAFETY AUDIT REPORT

NEW ARTS, COMMERCE AND SCIENCE COLLEGE, PARNER

Electrical Safety Audit

as per guidelines laid down in the
IE rules and NBC Codes
in 2021-22.

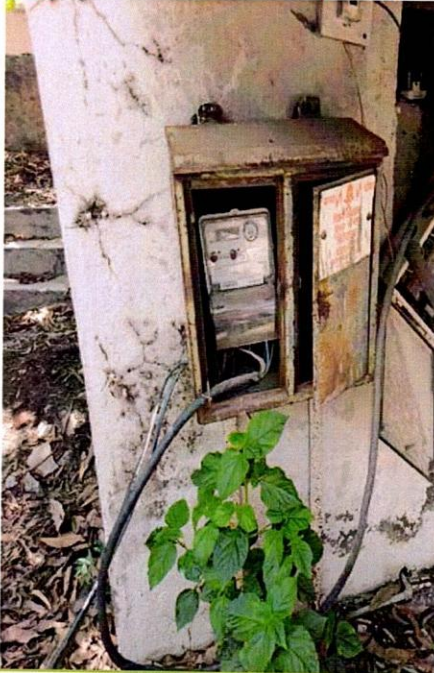
3

Glands are not used for cable entries in feeder.
Also unwanted openings observed
(Applicable to all electrical panels)

-Use glands for cable entrance. Gland helps to protect cable insulation from sharp edge cutting.
-Close unwanted opening properly.

IS 1646
Section 6.5

Very High

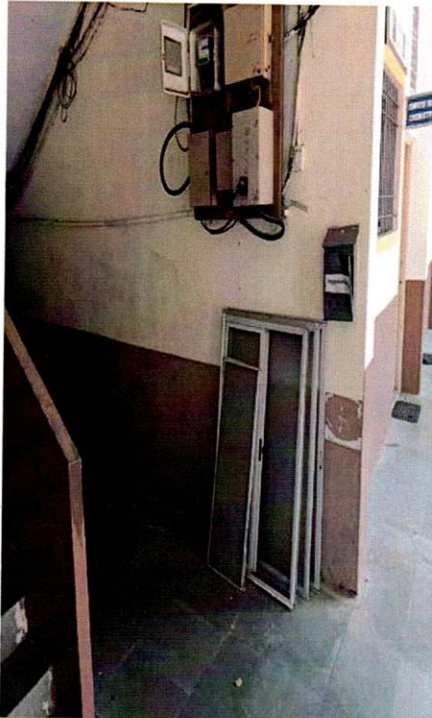
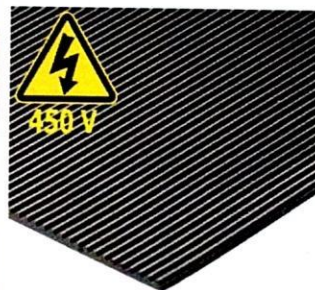
4

Rubber mat is not provided near all electrical panels.
(Common point for all electrical panel)

Provide rubber mat for panel. The rubber mat shall confirm to IS 15652

IE Rules 1956
Rule 36
IS 5424 :
1969

High

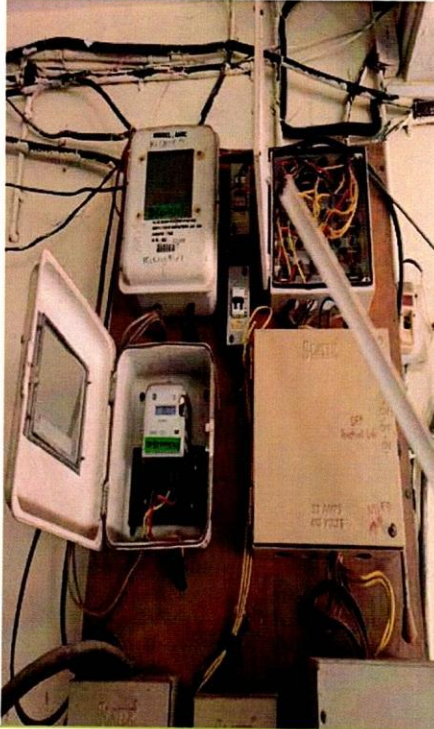
5

**Lugs are not used for electrical connections.
Open connections
(Common point for all electrical panel)**

A connection without lugs becomes loose over a period of time. Lugs should be used for good electrical connections.

**IE Rule 1956
Rule 117 (4)
IS 2412 :
1975**

Very High

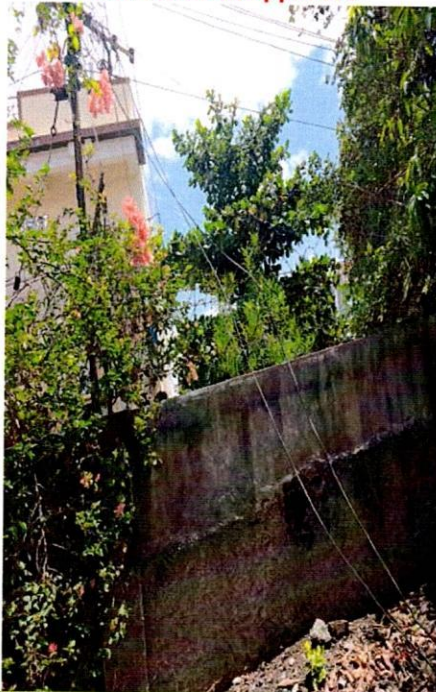
6

**Wiring is not dressed properly.
Cables are unsupported**

Wiring should be properly dressed. It should be properly supported and should not be hanged unsupported.

**IE 1956 Rule
36 (1)
IS 732:1989
IS:9537(Part-
1)-1980**

High

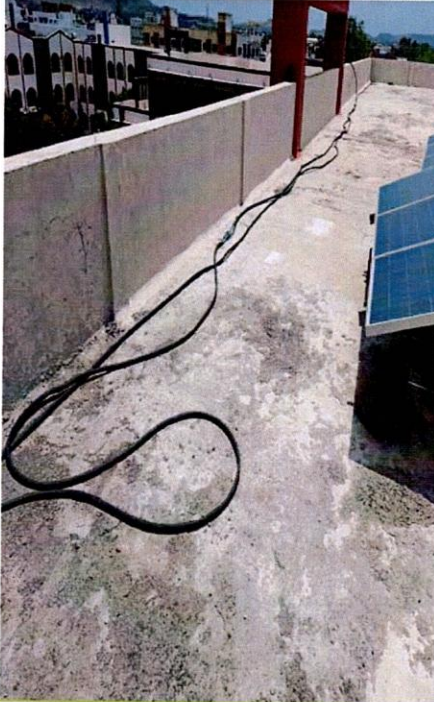
7

**Wiring is not dressed properly.
Cables are unsupported**

Wiring should be properly dressed. It should be properly supported and should not be hanged unsupported.

IE 1956 Rule 36 (1)
IS 732:1989
IS:9537(Part-1)-1980

High

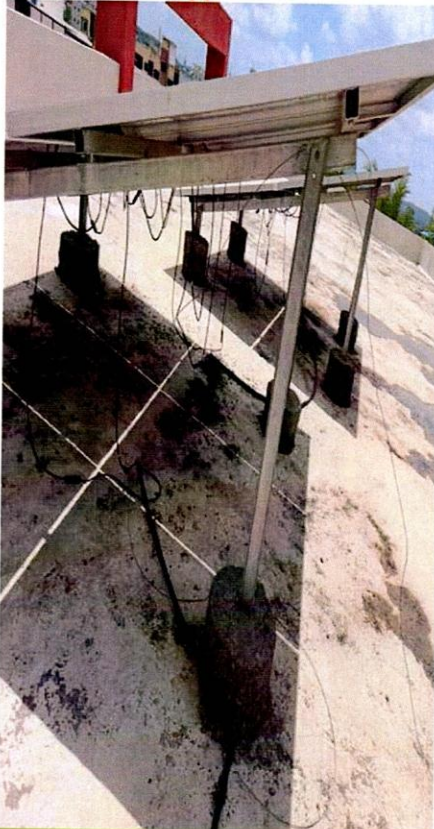
8

**Wiring is not dressed properly.
Cables are unsupported**

Wiring should be properly dressed. It should be properly supported and should not be hanged unsupported.

IE 1956 Rule 36 (1)
IS 732:1989
IS:9537(Part-1)-1980

High

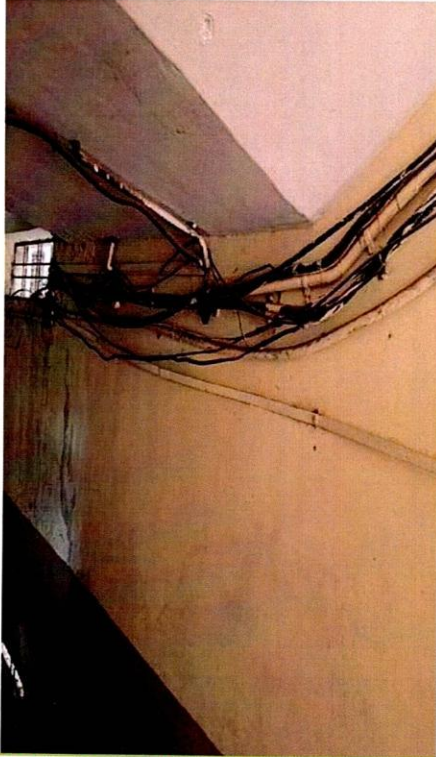
9

**Wiring is not dressed properly.
Cables are unsupported**

Wiring should be properly dressed. It should be properly supported and should not be hanged unsupported.

IE 1956 Rule 36 (1)
IS 732:1989
IS:9537(Part-1)-1980

High

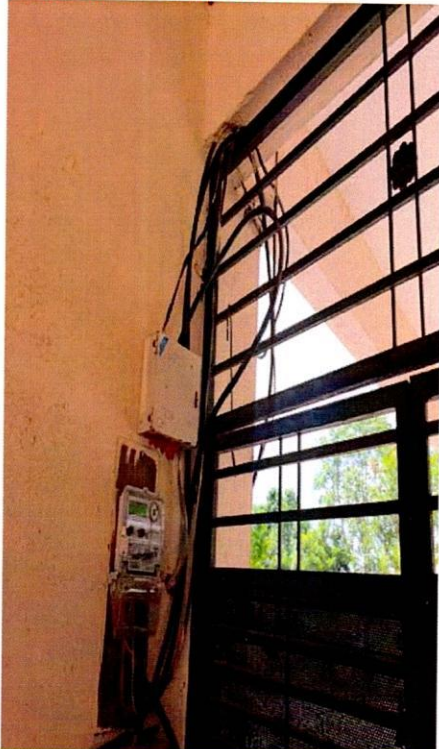
10

**Wiring is not dressed properly.
Cables are unsupported**

Wiring should be properly dressed. It should be properly supported and should not be hanged unsupported.

IE 1956 Rule 36 (1)
IS 732:1989
IS:9537(Part-1)-1980

High

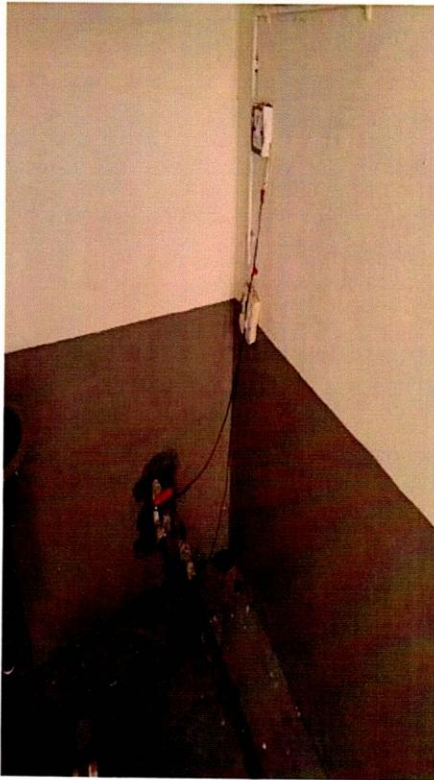
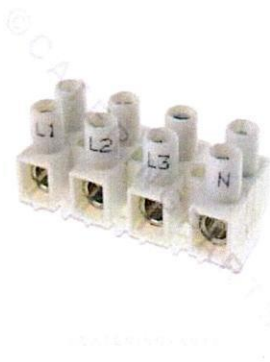
11

Insulation tape joints observed in wire.

Avoid insulation tape joints use proper size of connector for joint.

IE 1956 Rule
36 (1)
IS 732:1989

High

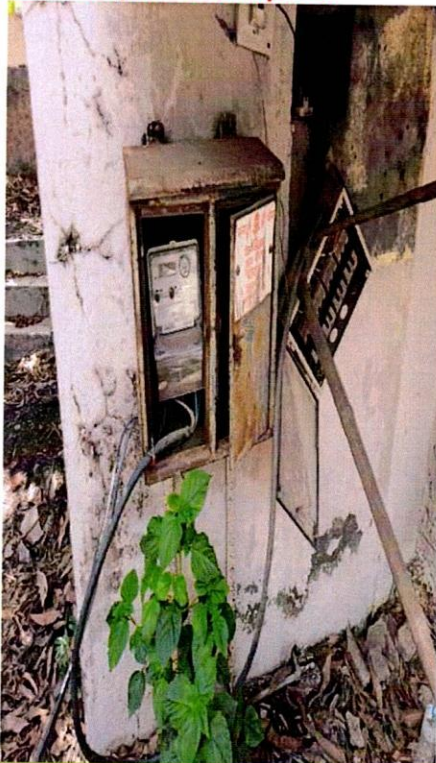
12

Electrical panel door opened

Closed the door when not in use or any electrical work

IS 1646
Section 6.5
IE 1956 Rule
36 (1)
IS 732:1989

High

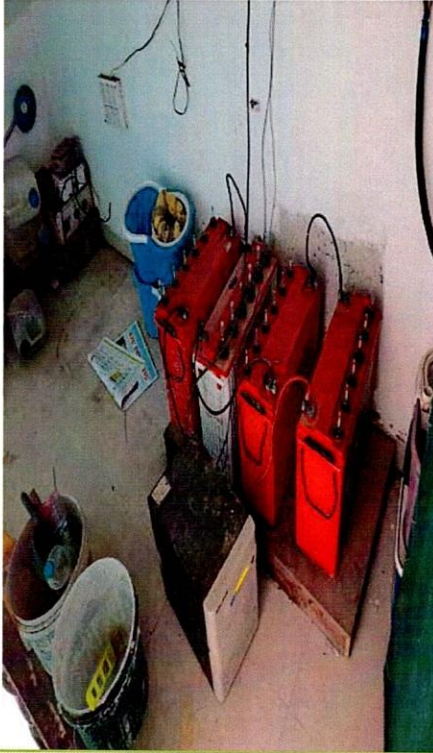
13

Unwanted material placed near batteries

-Remove unwanted material from batteries.
- Also placed the batteries at safe place or with as per standards of protection.

NFPA

High

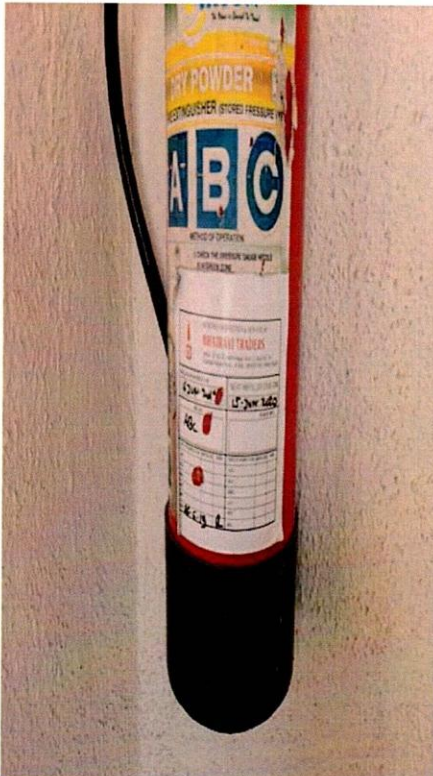
14

Fire extinguisher due date expires but it is still not renewed.

There should be regular inspection and maintenance of fire extinguisher from authorised person. Testing of the fire extinguisher should be done. Practice of regular AMC of fire extinguisher should be followed.

IS 2190-2010
Section
11,12,13,14,
15

Very High

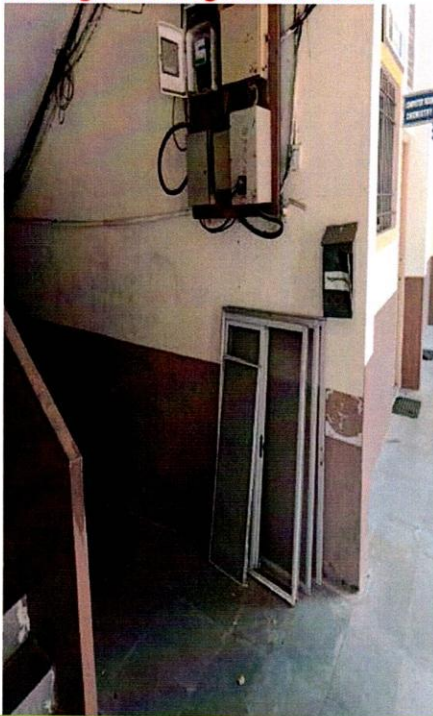
15	<p>No panel name boards No Single line diagram available</p>

<p>-It is highly recommended that there should be name boards for each electrical panels</p> <p>-Single line diagram of each panel should be pasted on each panel.</p> <p>IS 732:1989</p>	High
16	<p>No panel name boards No Single line diagram available</p>

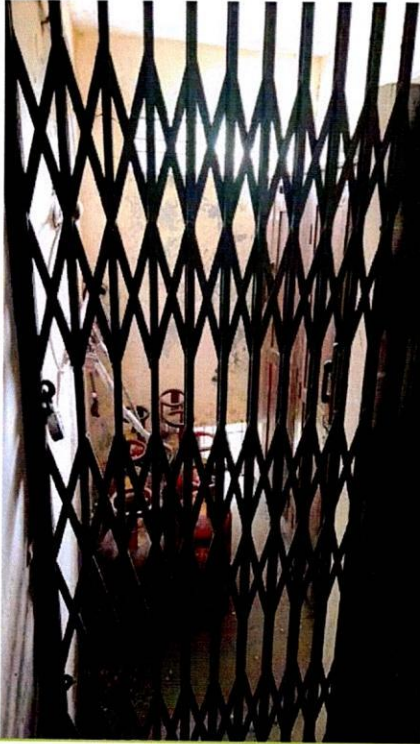
17

Wooden cupboards are observed in
LPG gas cylinder room

-Strictly prohibited any
active fire catching
material in LPG cylinder
room which prone to high
risk of fire hazards

Very High

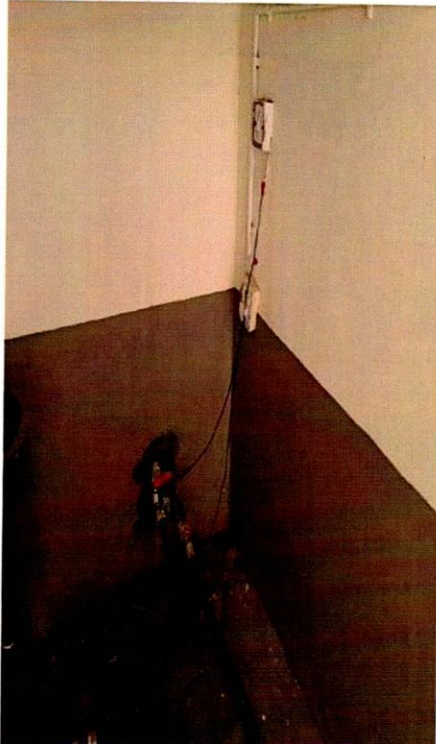
18

Electrical switchboard
Not properly fitted

It is highly recommended
that properly fixed the
electrical fittings or
switchboards.
It should not be hanging.

IE 1956 Rule
36 (1)
IS 732:1989
IS:9537(Part-
1)-1980

Very High

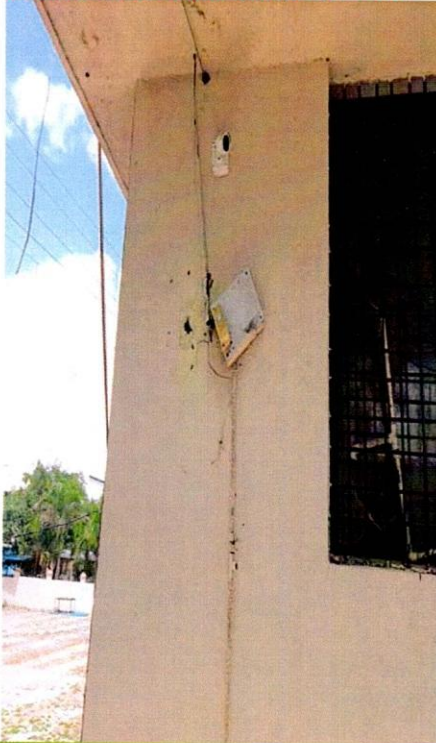
19

Electrical fitting not properly fitted

It is highly recommended that properly fixed the electrical fittings. It should not be hanging.

**IE 1956 Rule 36 (1)
IS 732:1989
IS:9537(Part-1)-1980**

Very High

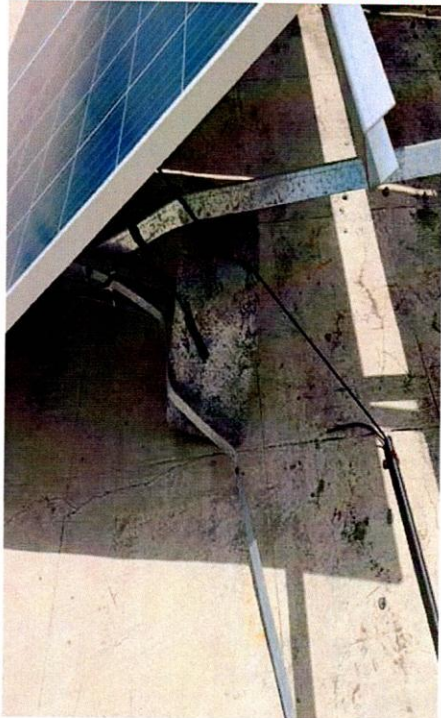
20

Open connections observed in wire.

It is highly recommended that to fix the open joints of solar panel connections as it is DC cable having DC voltage more than 100 V

**IE 1956 Rule 36 (1)
IS 732:1989**

High

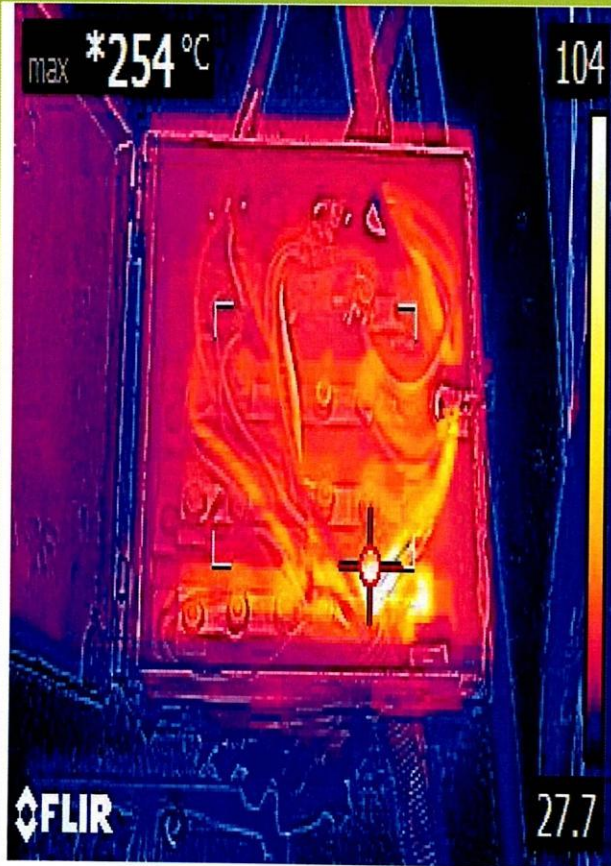
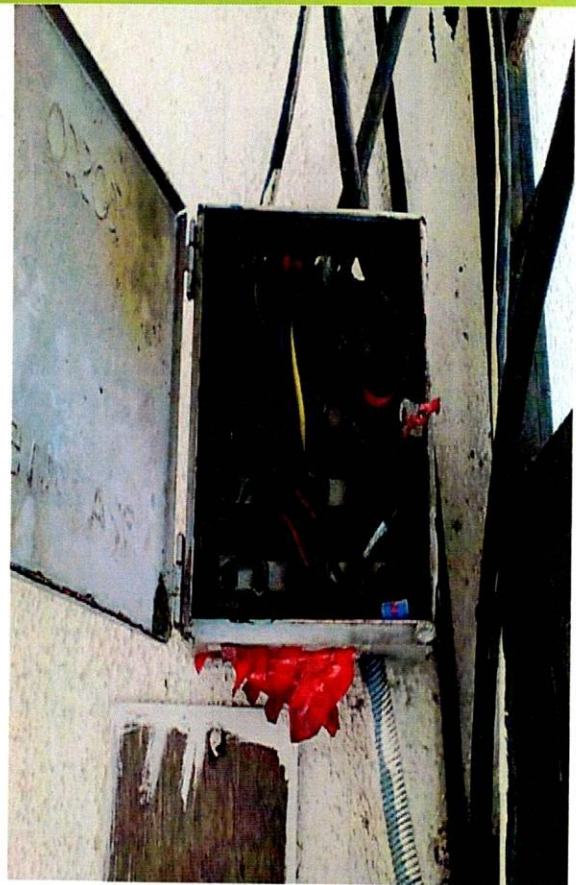
8199- Girl's hostel- Bus bar panel

Maximum Temperature Recorded	>254Deg.C
Observation	Hot spot at bus bar and cable connections.
Recommendation	Immediate take action for loose connections and proper wiring.
Priority Code	4

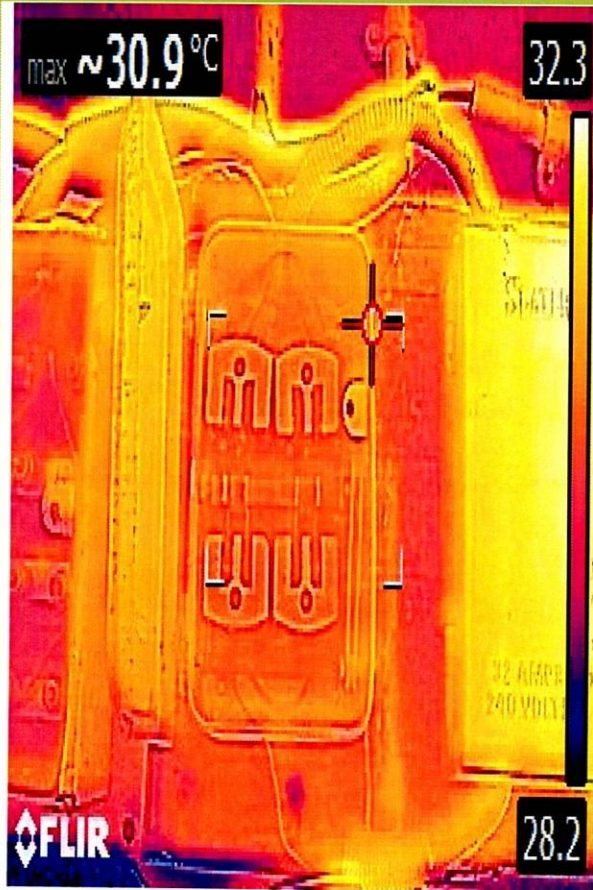
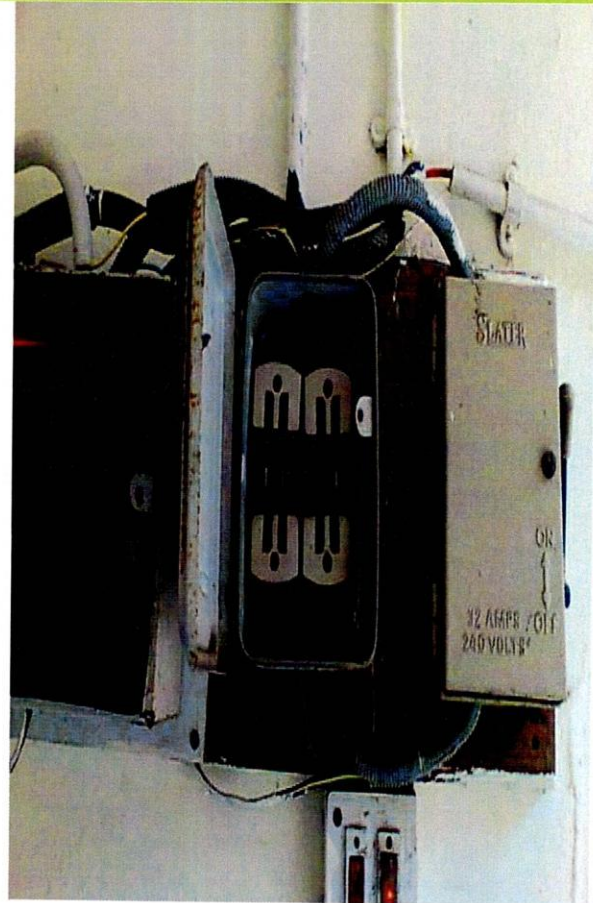
8201- Girl's hostel- Fuse panel

Maximum Temperature Recorded	30.9Deg.C
Observation	No abnormality found.
Recommendation	No action required
Priority Code	0

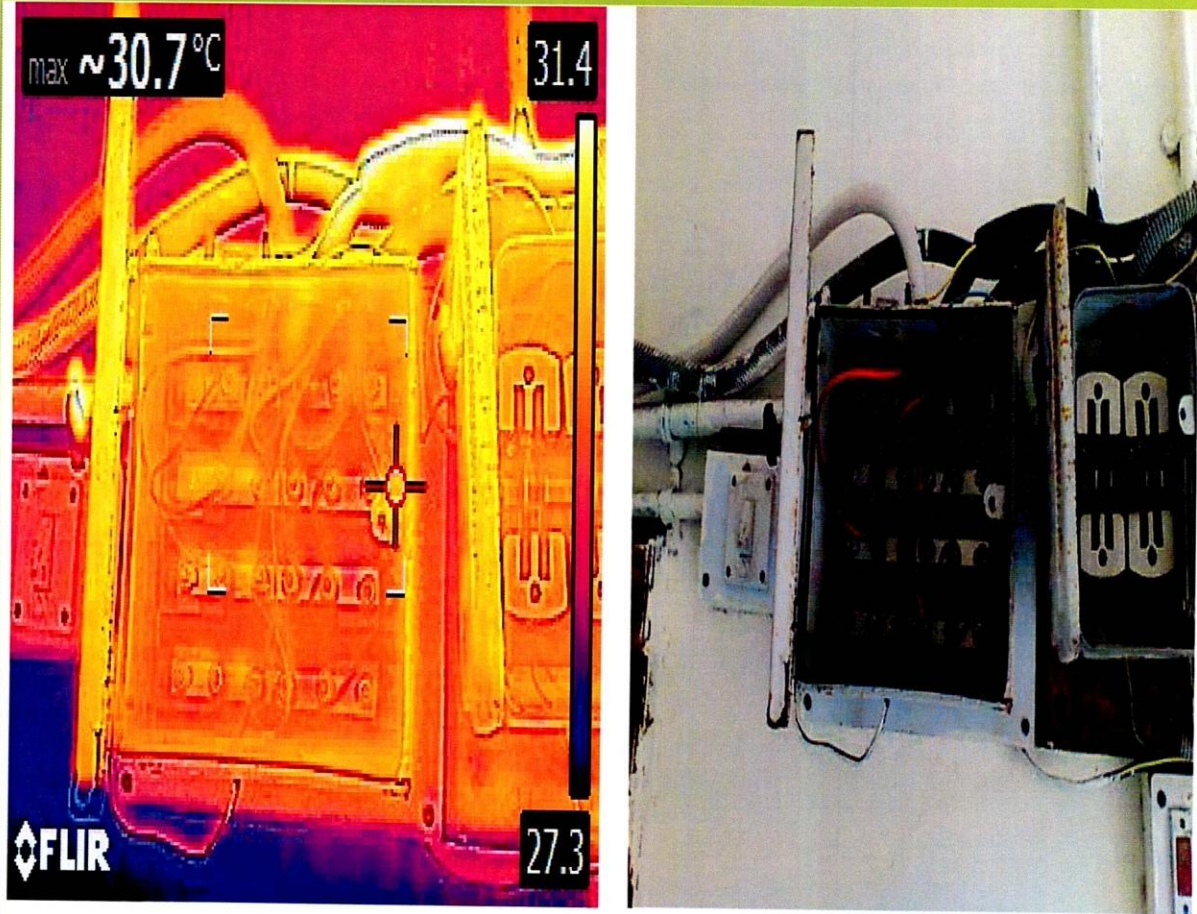
8203- Girl's hostel- Electrical panel

Maximum Temperature Recorded	30.7Deg.C
Observation	No abnormality found.
Recommendation	No action required
Priority Code	0

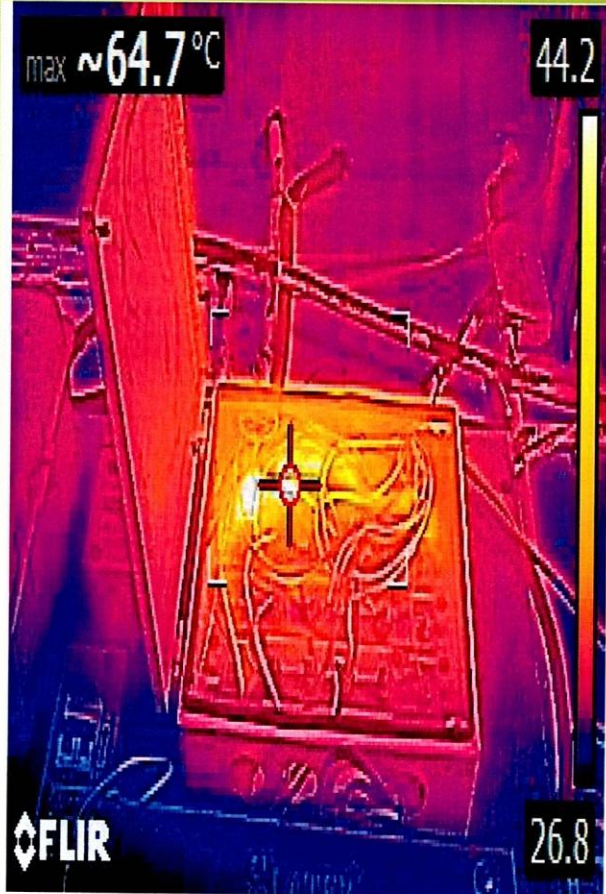
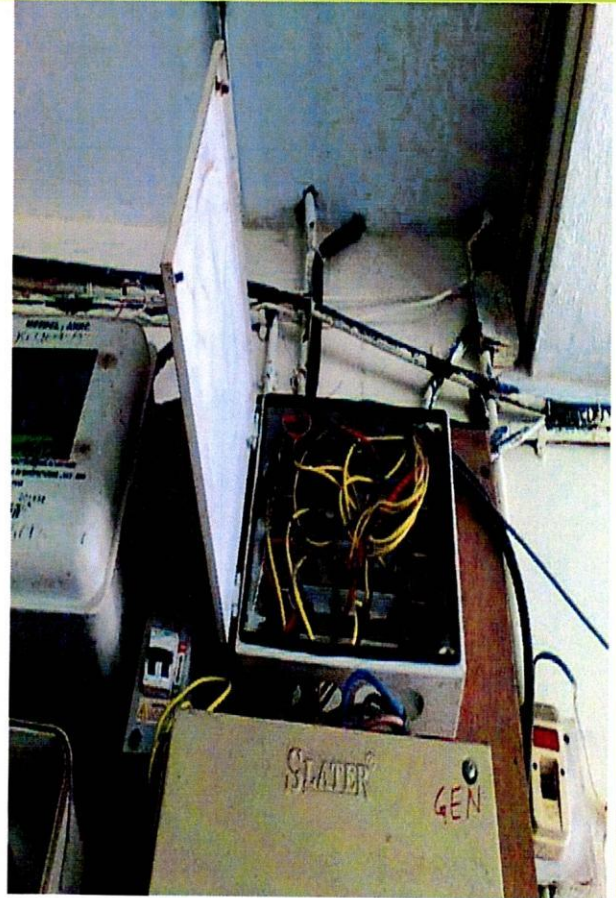
8209- Science building- Electrical panel

Maximum Temperature Recorded	64.7Deg.C
Observation	Hot spot at bus bar and cable connections.
Recommendation	Immediate take action for loose connections and proper wiring.
Priority Code	1

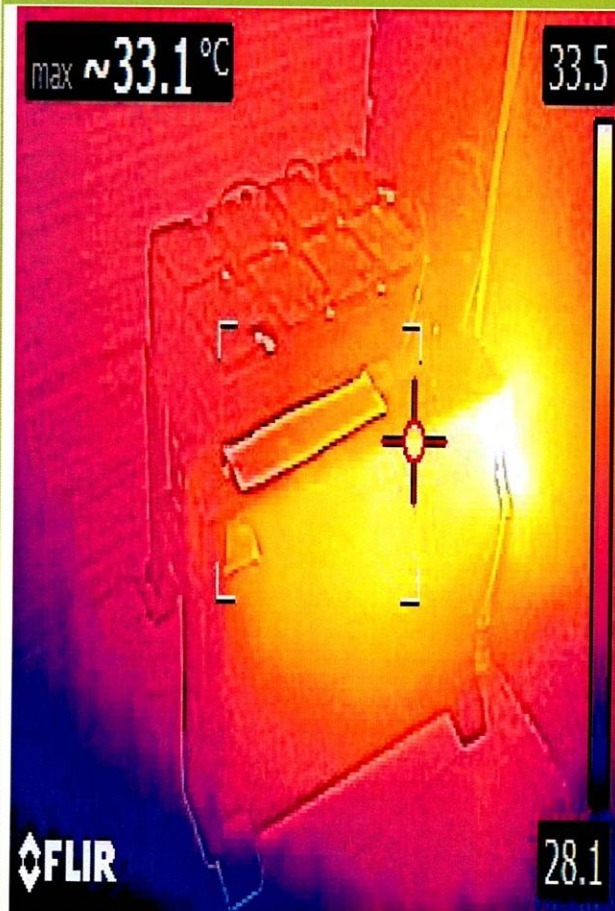
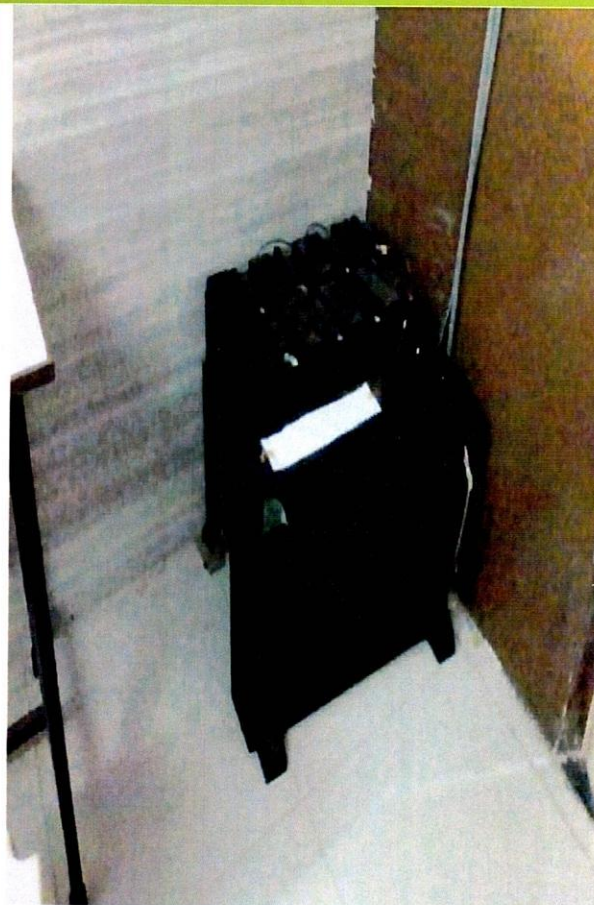
8211- Science building Batteries in lab

Maximum Temperature Recorded	33.1Deg.C
Observation	No abnormality found.
Recommendation	No action required
Priority Code	0

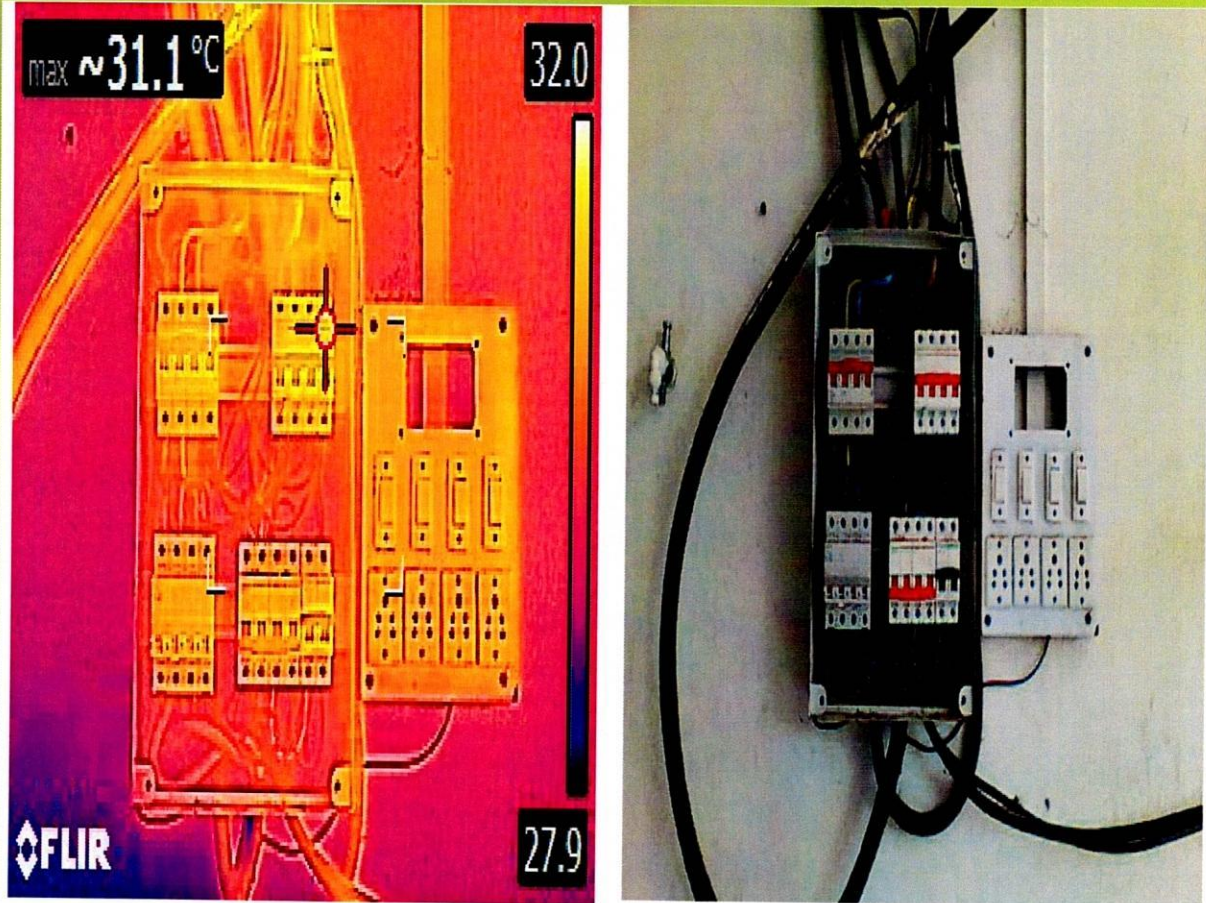
8213- Admin building- MCB panel

Maximum Temperature Recorded	31.1Deg.C
Observation	No abnormality found.
Recommendation	No action required
Priority Code	0

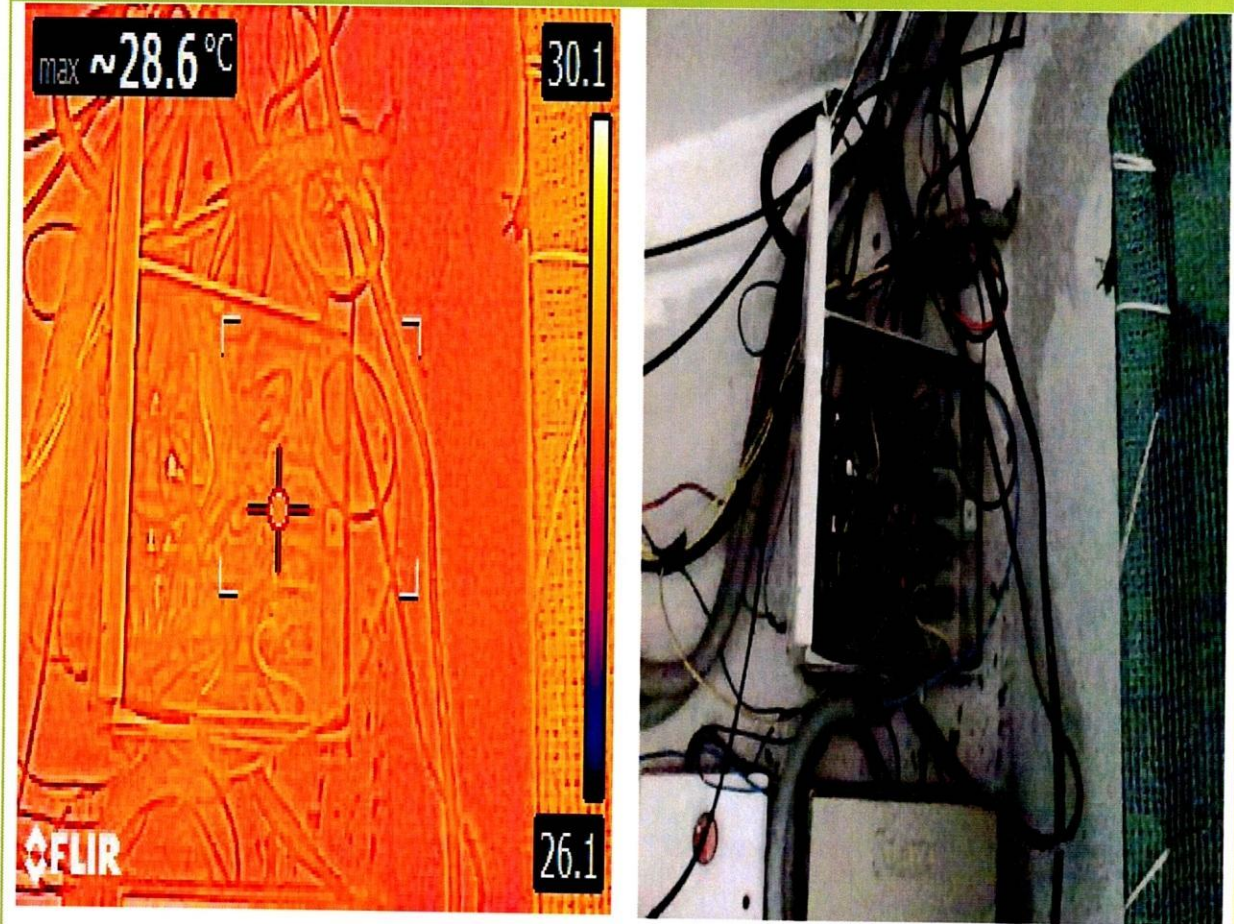
8215- Admin building- Bus bar panel

Maximum Temperature Recorded	28.6Deg.C
Observation	No abnormality found.
Recommendation	No action required
Priority Code	0

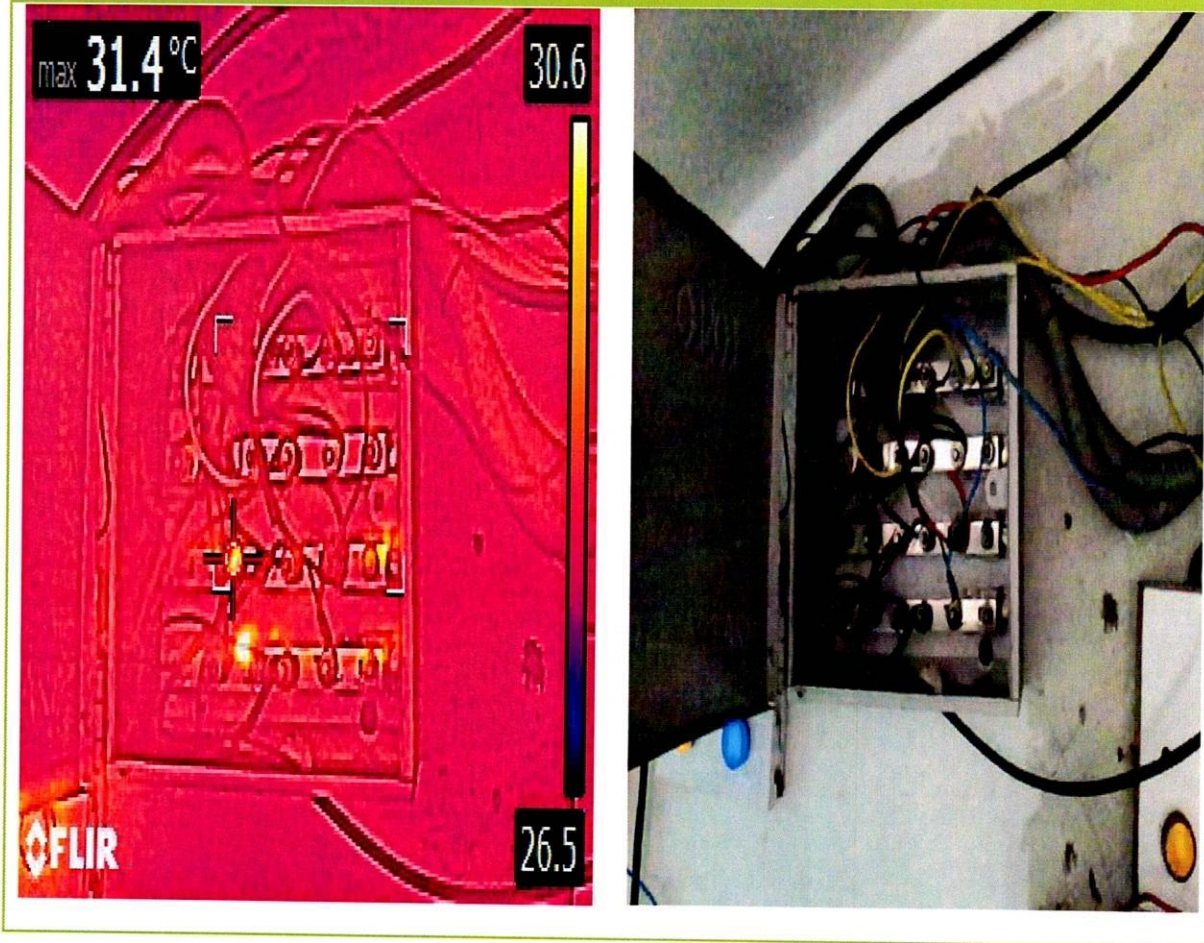
8217- Admin building- Bus bar panel

Maximum Temperature Recorded	31.4Deg.C
Observation	No abnormality found.
Recommendation	No action required
Priority Code	0

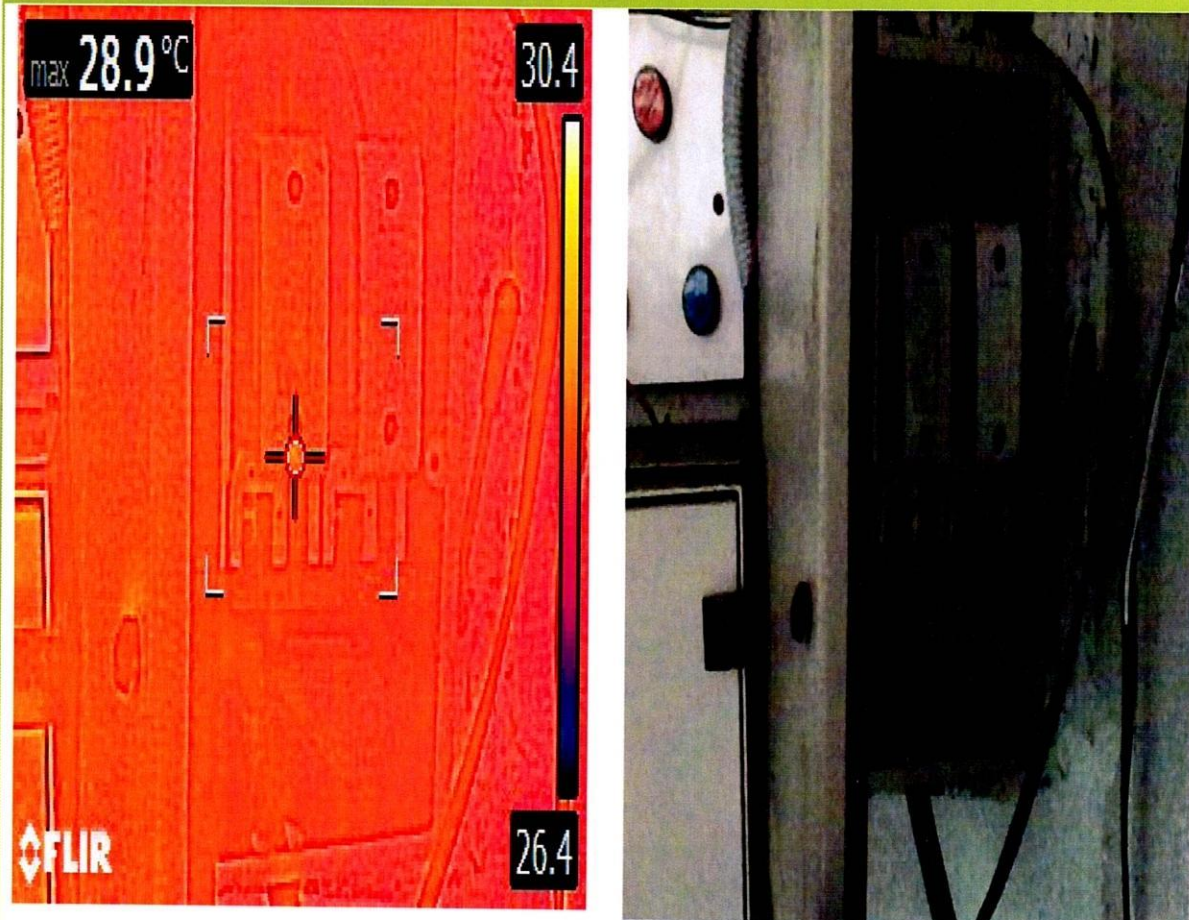
8219- Admin building- Fuse panel

Maximum Temperature Recorded	28.9Deg.C
Observation	Hot spot at bus bar and cable connections.
Recommendation	Check for loose connections of bolts regularly in maintenance.
Priority Code	2

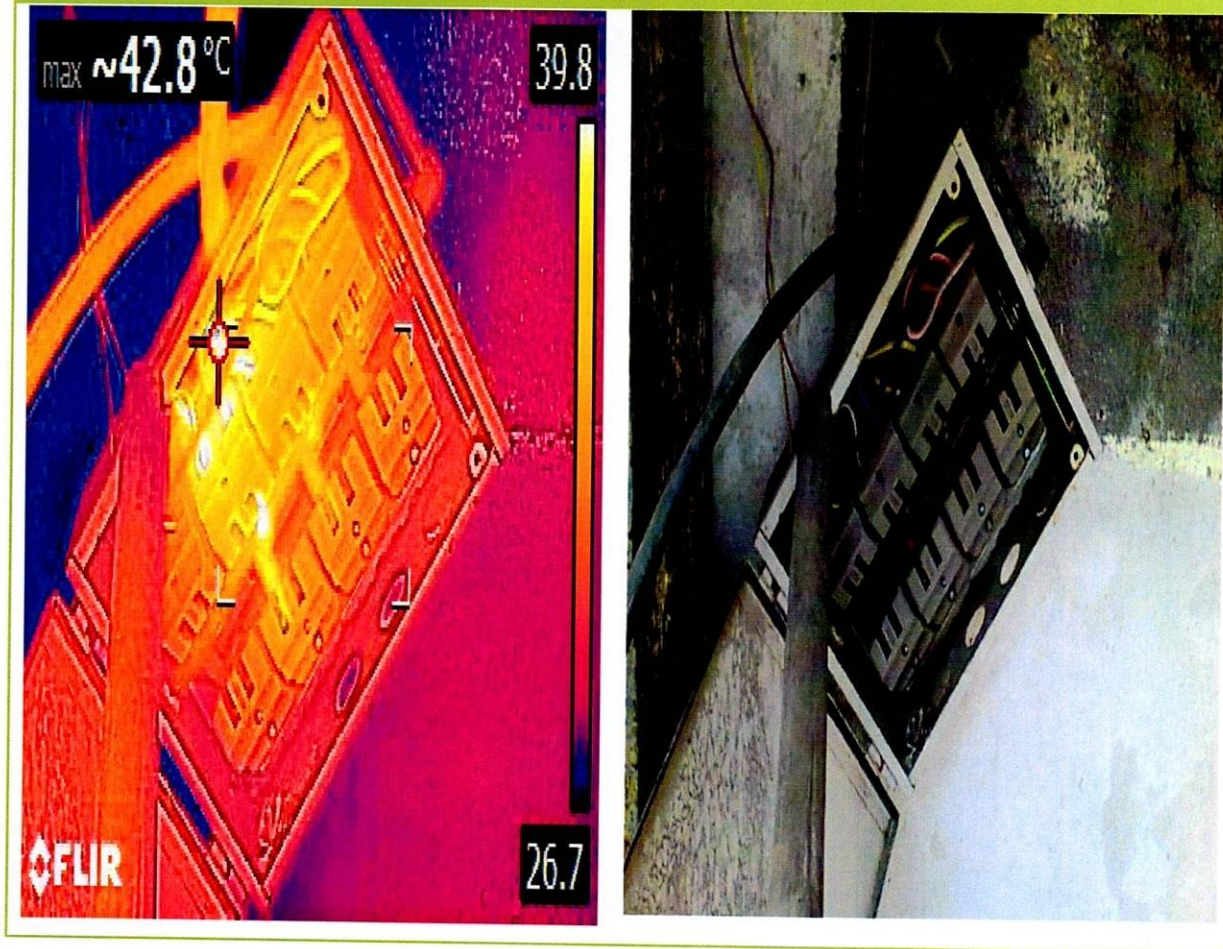
8223- Library- Electrical panel

Maximum Temperature Recorded	42.8Deg.C
Observation	Hot spot at cable connections.
Recommendation	Check for loose connections.
Priority Code	1

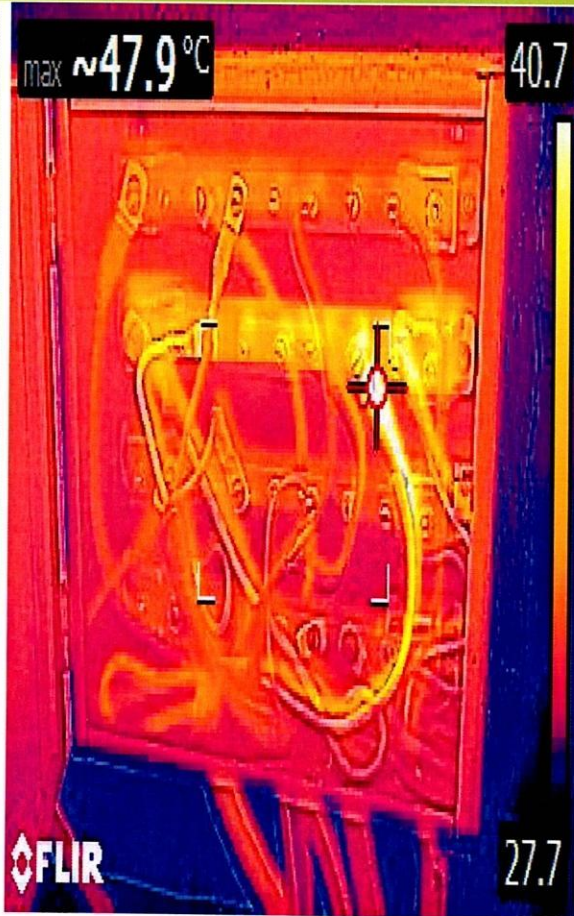
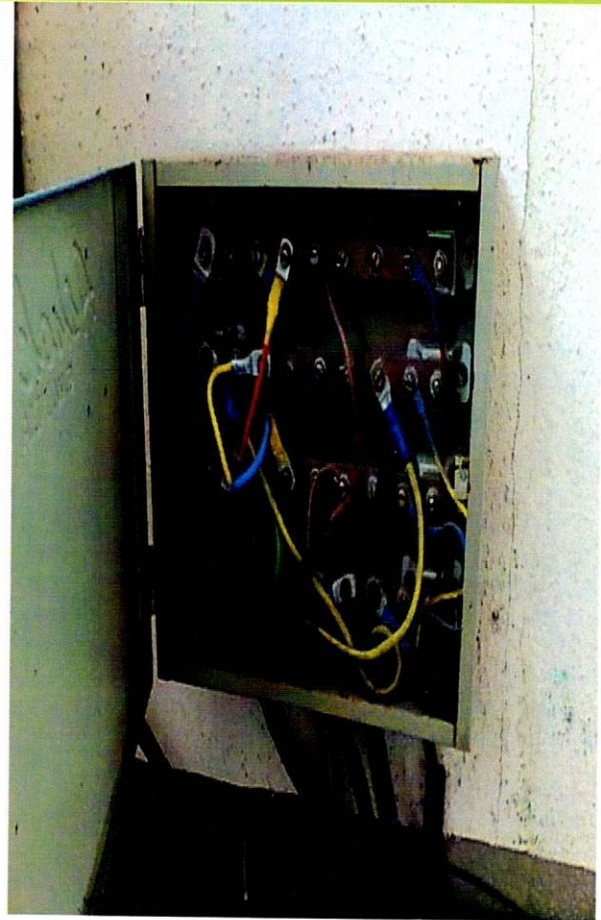
8225- Arts, Commerce building- Bus bar panel- Solar

Maximum Temperature Recorded	47.9Deg.C
Observation	Hot spot at bus bar and cable connections.
Recommendation	Check for loose connections.
Priority Code	1

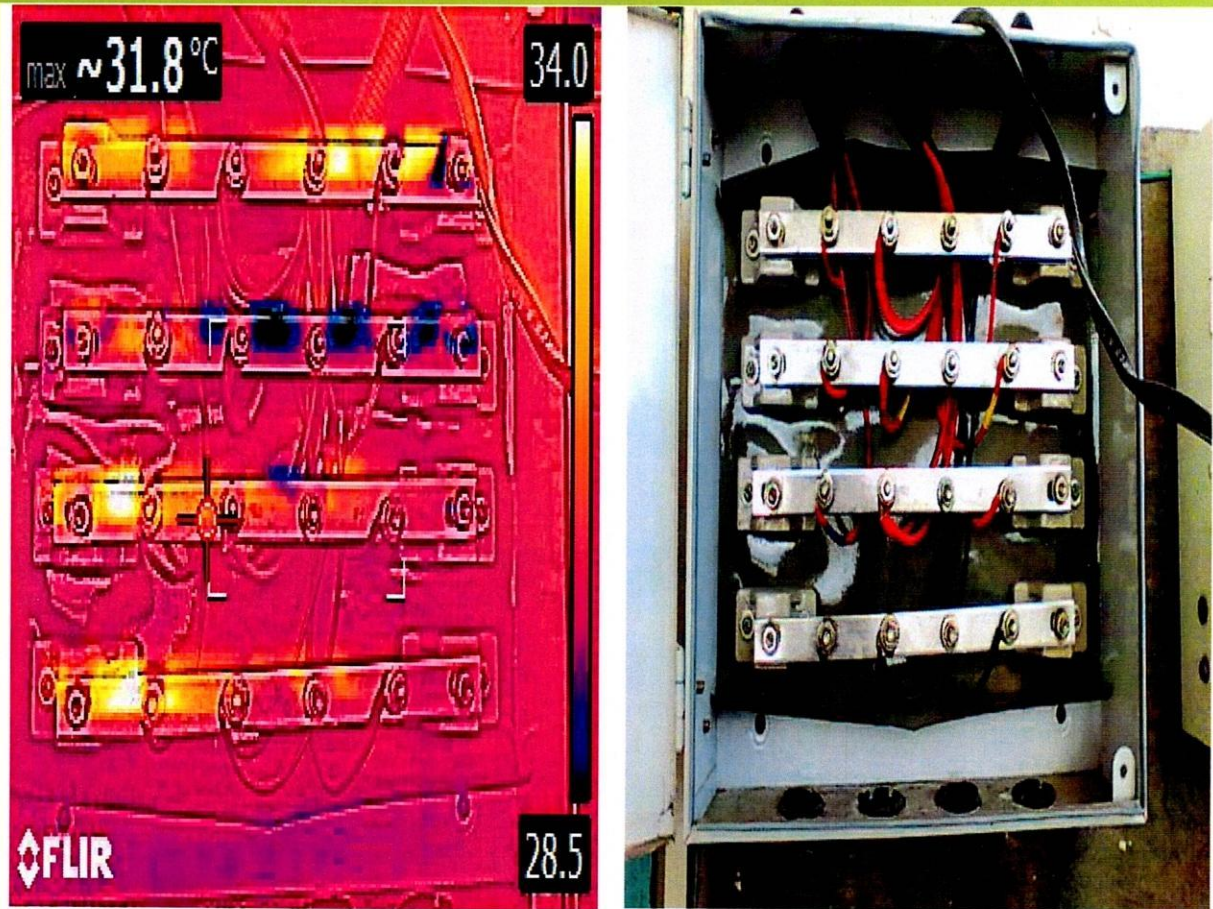
8227- Arts, Commerce building- Bus bar panel

Maximum Temperature Recorded	31.8Deg.C
Observation	No abnormality found.
Recommendation	No action required.
Priority Code	0

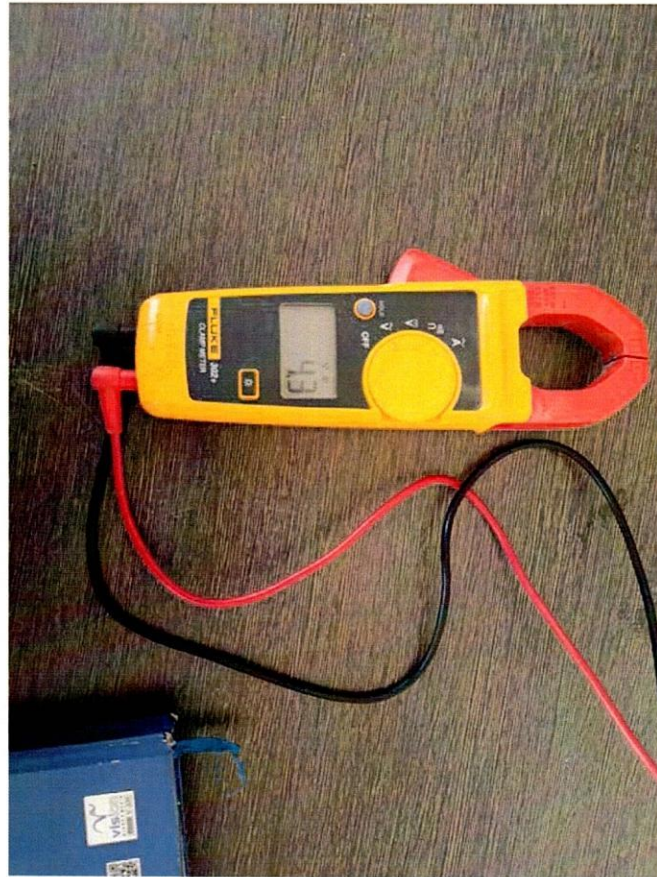
EARTHING TO NEUTRAL VOLTAGE TESTING

Sr No	Particular	Resistance	Remark
		Ohm	
1	Earthing to Neutral voltage	4.3	At higher side

It is recommended that maintain the eating pits in the college premises as per Indian standards. Regularly pour the water for low resistance of earth pit.
