ELECTRICAL SAFETY AUDIT REPORT

NEW ARTS, COMMERCE AND SCIENCE COLLEGE, PARNER

This THERMOGRAPHIC INSPECTION is designed to assess the performance of all switchgears, cable terminations, bus bar joints on site and to highlight areas which require attention.

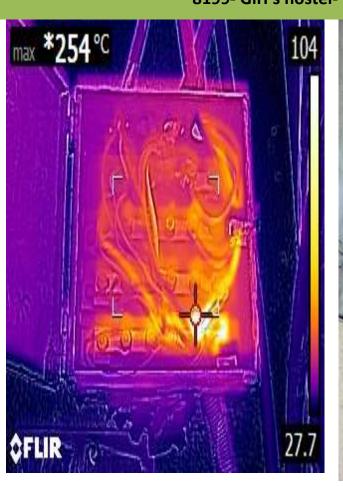
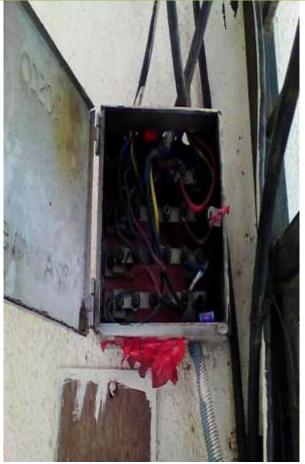
8199- Girl's hostel- Bus bar panel

Maximum Temperature Recorded	>254Deg.C
Observation	Hot spot at bus bar and cable connections.
Recommendation	Immediate take action for loose connections and proper wiring.
Priority Code	4

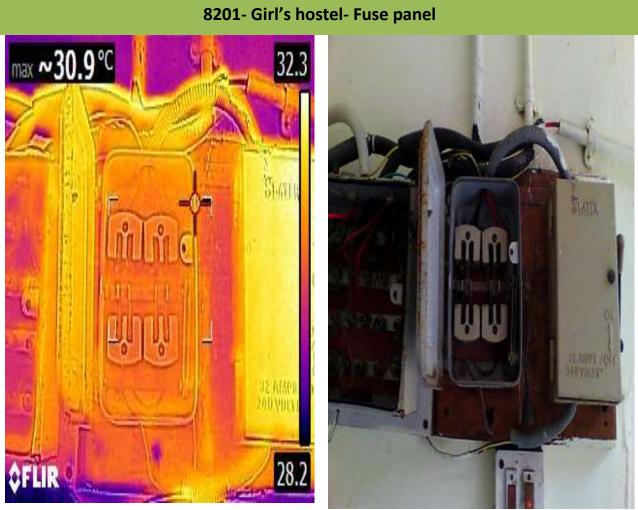
Maximum Temperature Recorded	30.9Deg.C
Observation	No abnormality found.
Recommendation	No action required
Priority Code	0

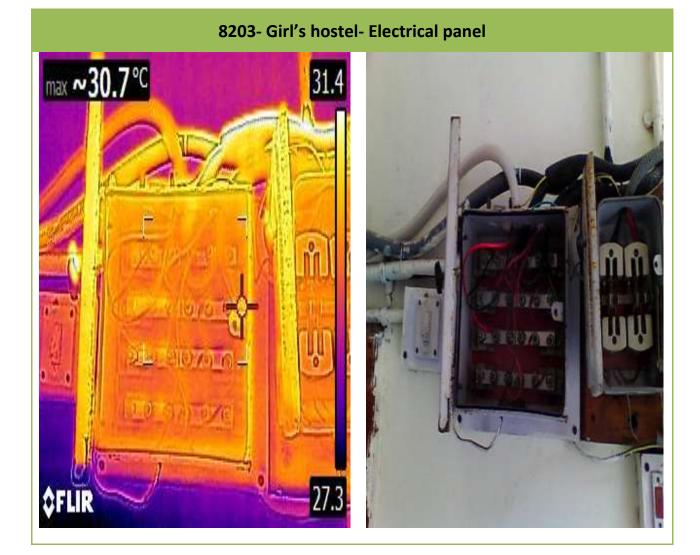
Maximum Temperature Recorded	30.7Deg.C
Observation	No abnormality found.
Recommendation	No action required
Priority Code	0

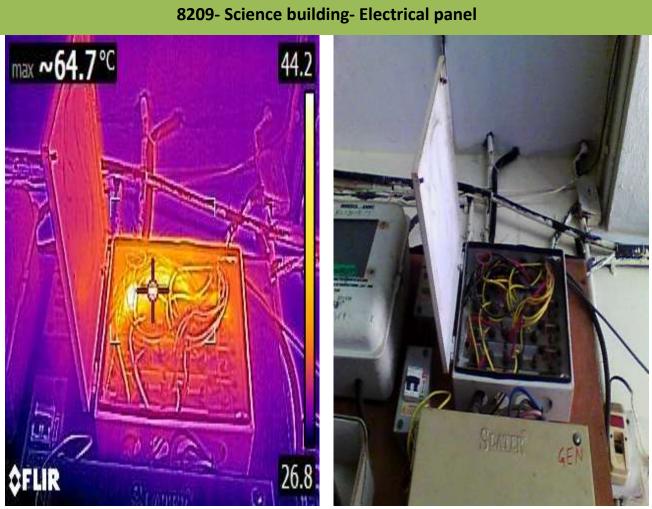
Maximum Temperature Recorded	64.7Deg.C
Observation	Hot spot at bus bar and cable connections.
Recommendation	Immediate take action for loose connections and proper wiring.
Priority Code	1

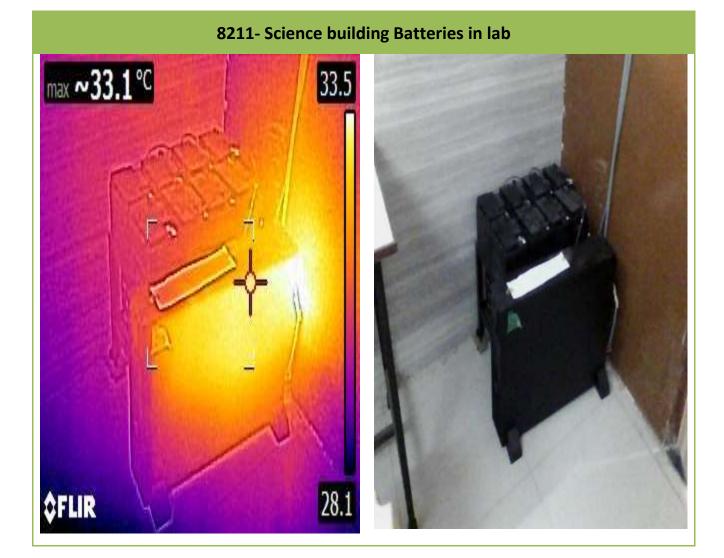
Maximum Temperature Recorded	33.1Deg.C
Observation	No abnormality found.
Recommendation	No action required
Priority Code	0

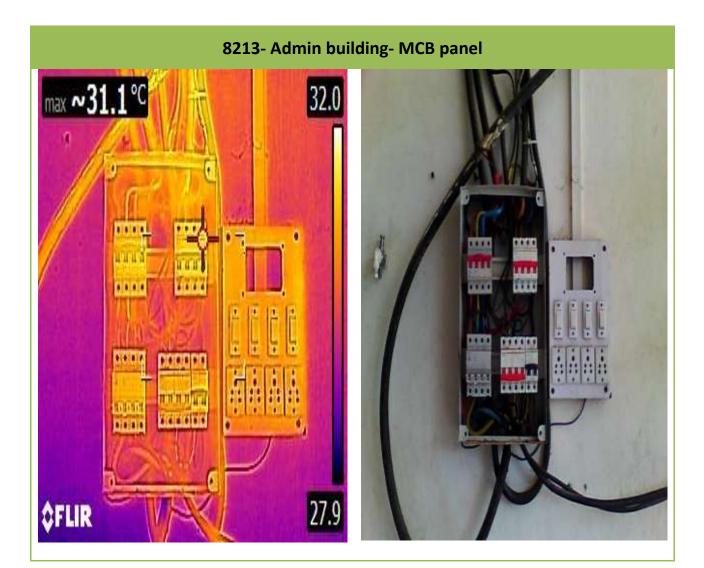
Maximum Temperature Recorded	31.1Deg.C
Observation	No abnormality found.
Recommendation	No action required
Priority Code	0

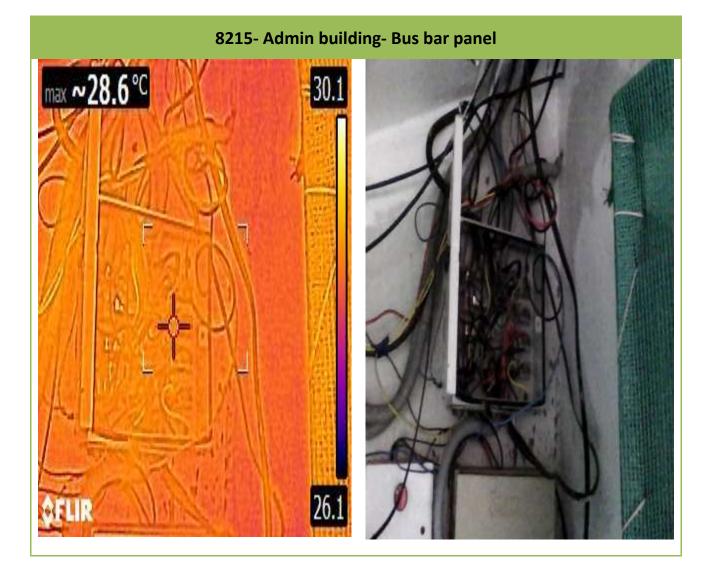
Maximum Temperature Recorded	28.6Deg.C
Observation	No abnormality found.
Recommendation	No action required
Priority Code	0

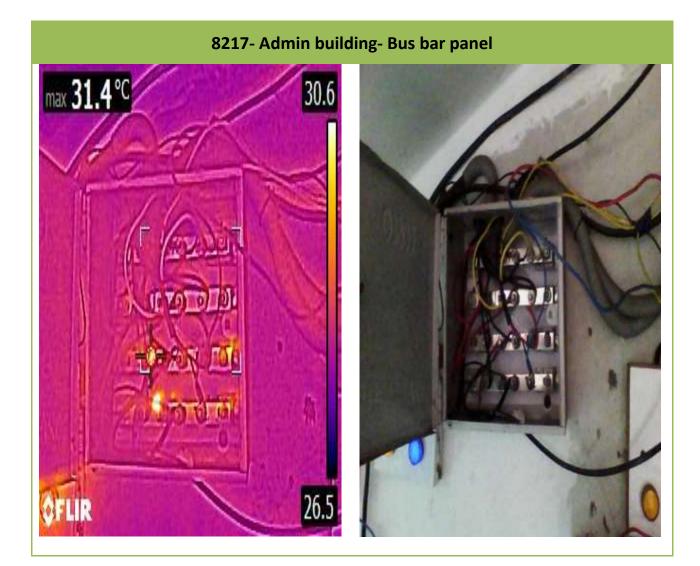
Maximum Temperature Recorded	31.4Deg.C
Observation	No abnormality found.
Recommendation	No action required
Priority Code	0

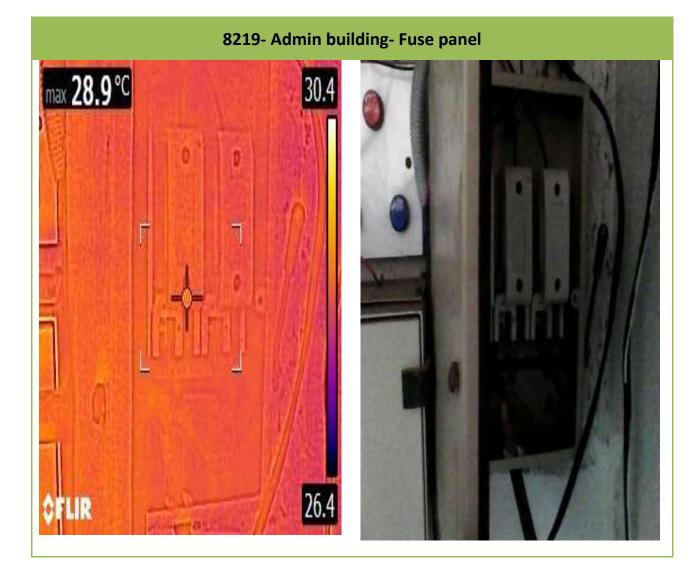
Maximum Temperature Recorded	28.9Deg.C
Observation	Hot spot at bus bar and cable connections.
Recommendation	Check for loose connections of bolts regularly in maintenance.
Priority Code	2

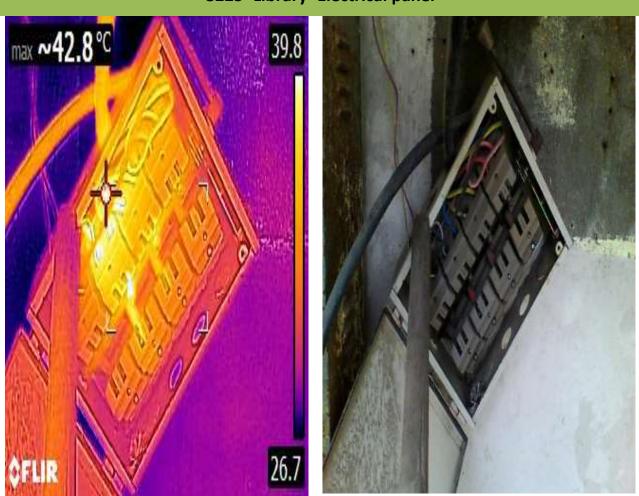
8223- Library- Electrical panel

Maximum Temperature Recorded	42.8Deg.C
Observation	Hot spot at cable connections.
Recommendation	Check for loose connections.
Priority Code	1

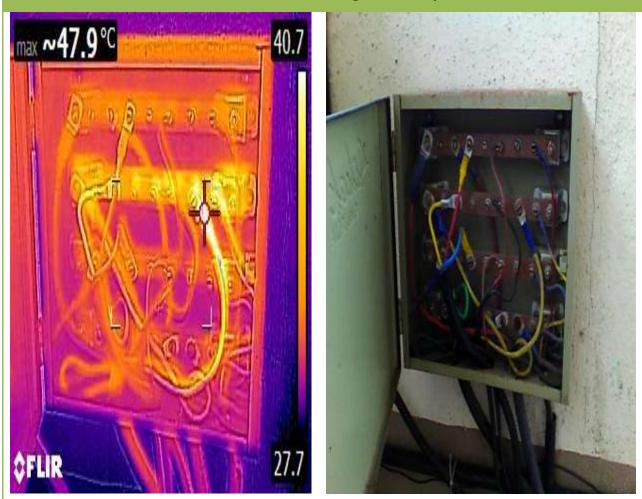
8225- Arts, Commerce building- Bus bar panel- Solar

Maximum Temperature Recorded	47.9Deg.C
Observation	Hot spot at bus bar and cable connections.
Recommendation	Check for loose connections.
Priority Code	1

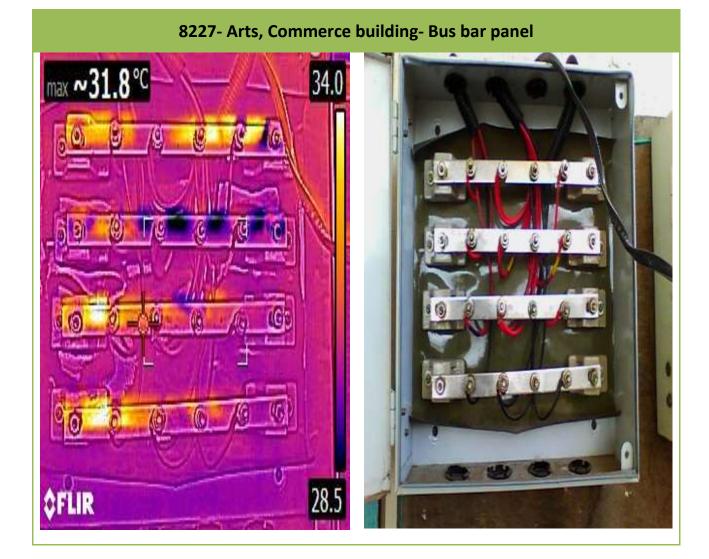
Maximum Temperature Recorded	31.8Deg.C
Observation	No abnormality found.
Recommendation	No action required.
Priority Code	0

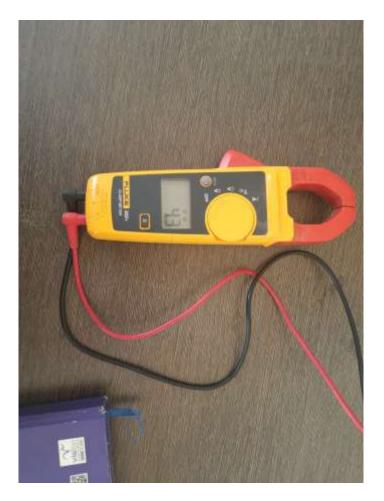
EARTHING TO NEUTRAL VOLTAGE TESTING

Sr No	Particular	Resistance	Remark
		Ohm	
1	Earthing to Neutral voltage	4.3	At higher side

It is recommended that maintain the eating pits in the college premises as per Indian standards. Regularly pour the water for low resistance of earth pit.
